**DCH Marine, Inc.**  
**141 Paddington Rd.**  
**Venice, Fl. 34293**  
***Captain Don Hunter, MMS***  
**(941) 485-0999**  
U.S. Surveyors Association Member #40208H  
www.dchmarine.com

March 21, 2004

***Our File #*** 04-102

The subject vessel is a 1984 Kadey-Krogen 42' trawler. The vessel bears hull identification number XXXXXXXXXX and Florida state registration # FL XXXX XX. This vessel is named "XXXXXX". It is powered by a single Ford/Lehman six cylinder, naturally aspirated, 120 horsepower, diesel engine. There is also an 8kw generator located in the engine room.

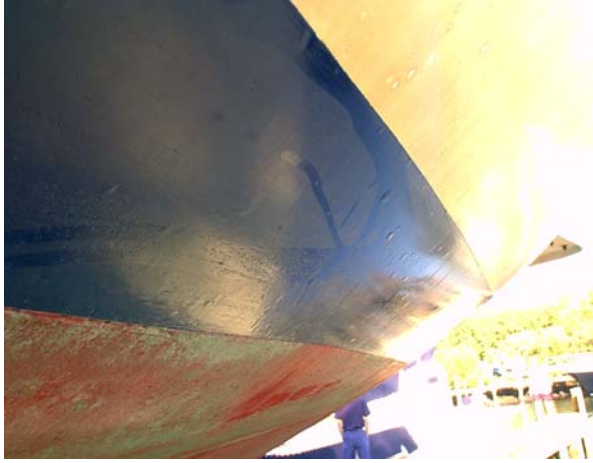
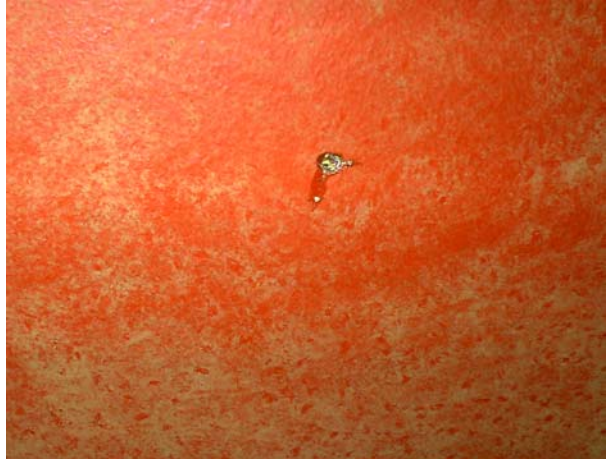
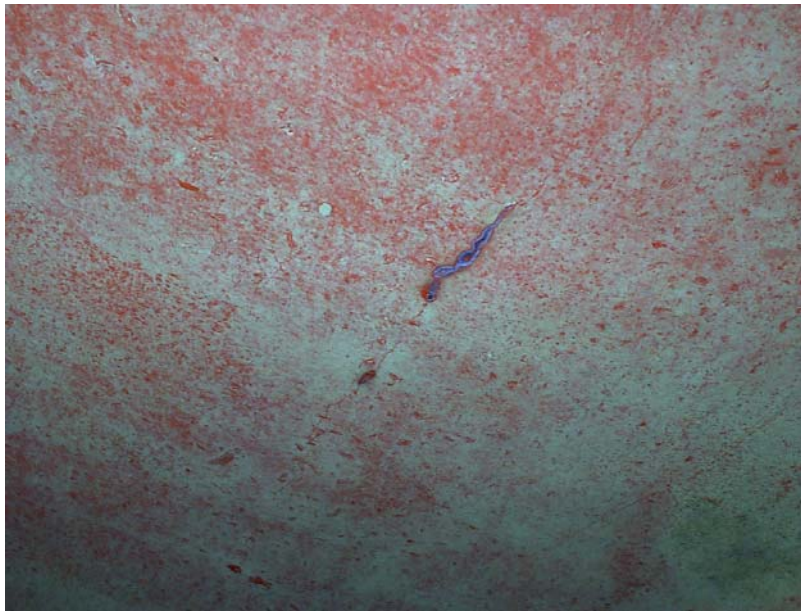
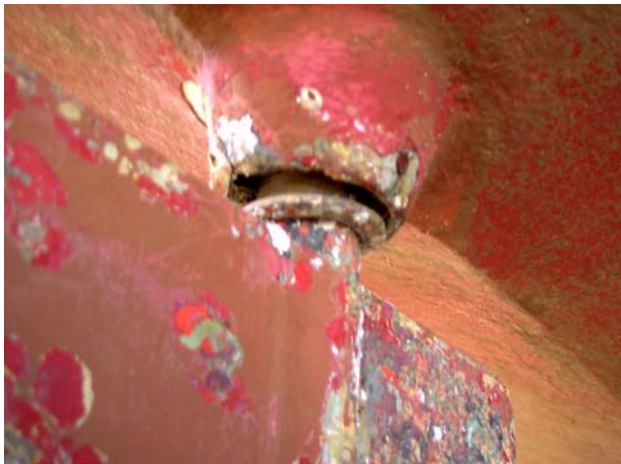
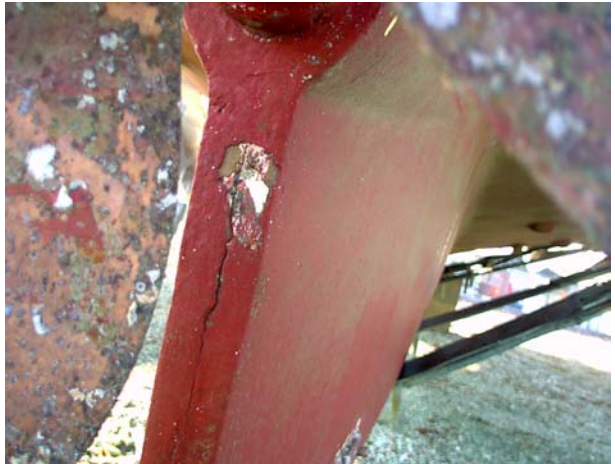
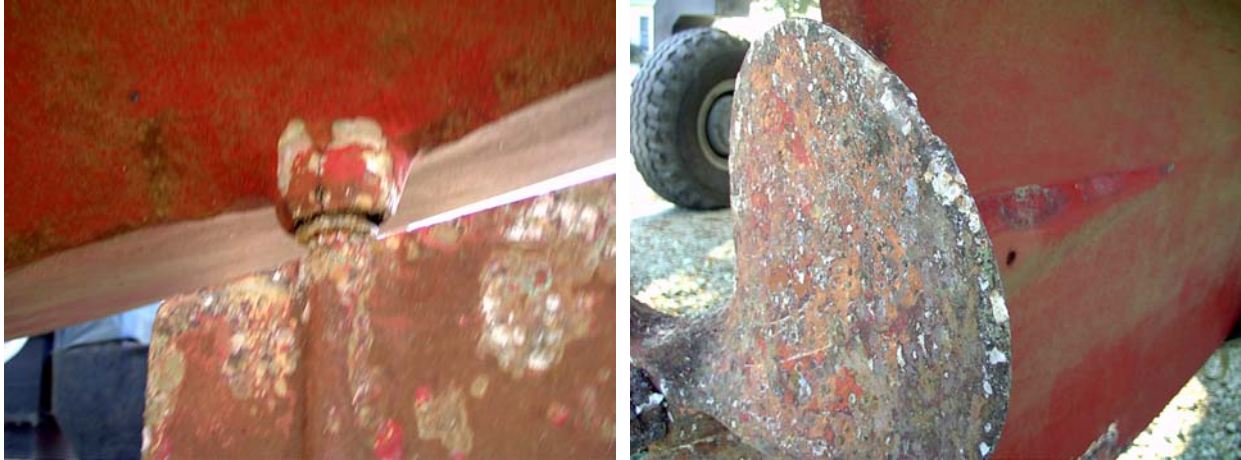
Hull soundings usually provide one of the best indicators of the condition of the laminate. A solid fiberglass hull will sound almost like hitting a piece of steel with my plastic hammer that is unless you hit an area of delamination. Delamination usually sounds like a "thud". It is difficult to discern the condition of the hull on this vessel due to the coring. I can tell you most of the hull sounds fine on this vessel and I can also tell you the two areas in question near the stern, sound different. What I can't tell you is what the actual cause of the difference is, only speculation. It is also very possible the vessel came out of the mold this way. The following photos show a sampling of the blisters, a stress crack in the hull bottom on the port side at the bottom of one of the "hollows", a separation at the back of the keel, loose rudder bushings a cracked rudder tube and some of the damage to the propeller.

The previous owner has notes in the log about shimming and adjusting the rudder. It doesn't specify what the problem was and why this was necessary. I think his modifications have transferred some stress to the fiberglass tube, which houses the rudder shaft. This in turn caused the crack you see in the left photo above, which then allowed the bushing to fall out. This problem has then caused another issue. This crack has allowed seawater to enter the keel and seep into the hull, as evidenced by the following photo. This picture shows a view inside the hull, looking aft at the area above the propeller shaft. This seep is not in a cored area of the laminate but it is still something which should be repaired and the rudder shaft inspected for damage. The separation in the keel should be repaired before it travels upward to the cutlass bearing area. The propeller has two blades, which have substantial damage, and one blade, which is bent forward by at least 1/4".

- 5) \*\*\* Recondition/Replace vessel's propeller due to bent and chipped blades causing vibration in driveline while underway. This could cause other damage to driveline if operated uncorrected.

- 10) Replace sacrificial anode on rudder due to less than 50% remaining.
- 11) Repair rudder shaft guide tube and inspect rudder shaft for damage either from wear or electrolysis and repair as needed.

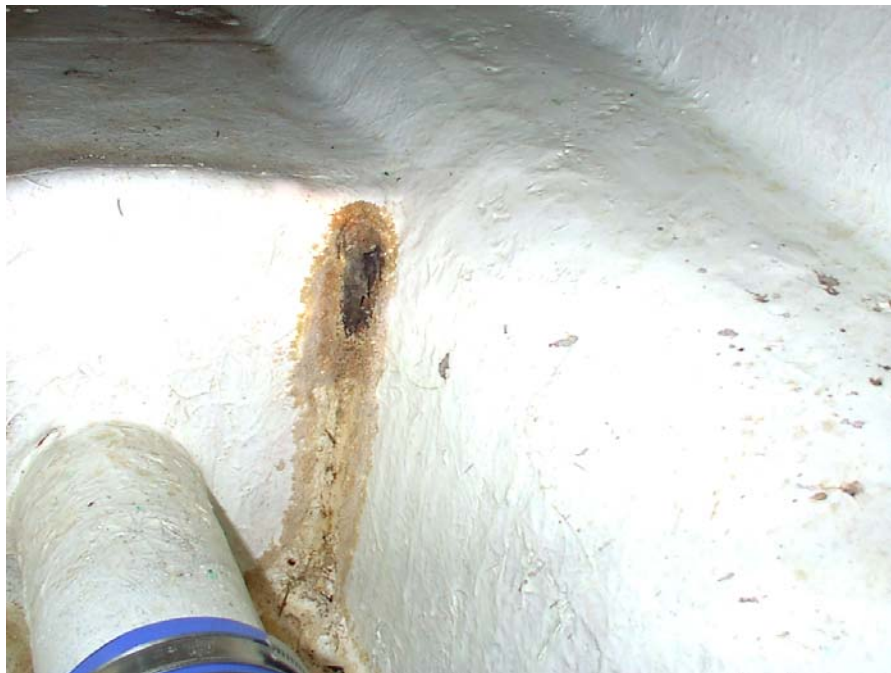
As for the hull bottom in the deflection areas, it is my belief that there is movement of the outer

laminates while under way which, has caused enough flex in the fiberglass to cause a stress crack at the bottom of the concave area on the port side. The cause of this movement remains unknown until, and if, a core sample is performed. Let me state that this vessel has a very thick inner laminate skin and a very thick outer laminate skin so even if the core was proven to be deteriorated, I would not be convinced it would be an issue with this vessel, based on its speed and hull design.

- 16) Repair fiberglass taping on aft edge of port side fuel tank-to- hull joint.
- 17) Repair stress crack in port side hull bottom and keel seam aft in conjunction with a bottom job to ensure no seawater is allowed to enter into the coring material.

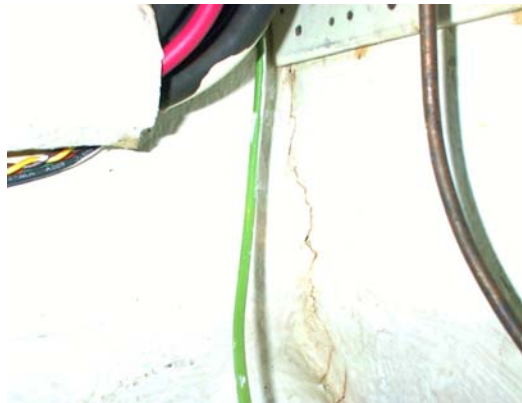
I sounded the interior of the vessel's hull with the phenolic hammer as well as the engine bed stringers. I found the port side stringer delaminated at the forward bulkhead. This delamination could signify rot in the stringer, especially due to the fact there is a limber hole drilled through the stringer at the area in question. The area of delamination runs approximately 16" rearward from the front engine compartment bulkhead, below the electrical panel. This situation has apparently allowed some movement in the stringer, as evidenced in the following photo. Notice the crack in the gelcoat where it meets the bulkhead. This area is forward of the forward engine mount by roughly 3 feet.

This stringer will need to be monitored for progression of the problem. If the engine ever needs to be removed for servicing or for replacement, it would be a good time to repair this area due to its proximity to the problem area.

- 21) Suggest having life raft serviced and updated as needed.
- 22) Suggest having all fire extinguishing systems serviced by qualified personnel.
- 23) Suggest formulating a repair plan for future repairs to port side stringer at forward engine room bulkhead.

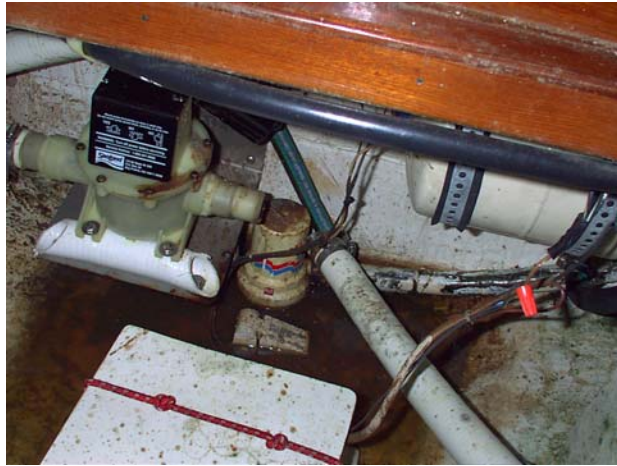
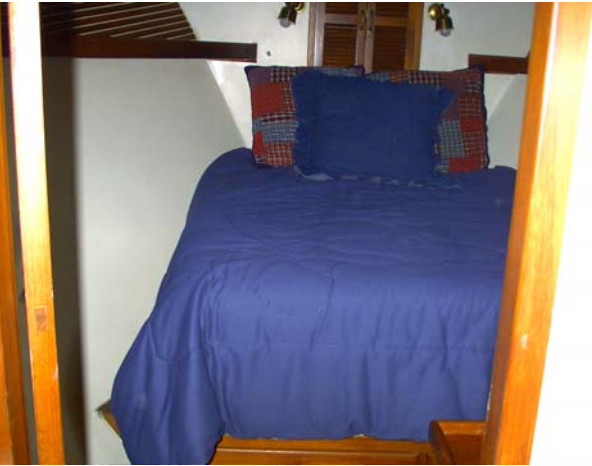
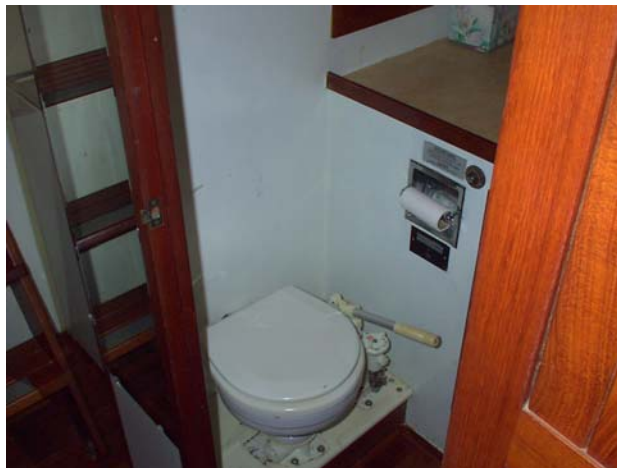
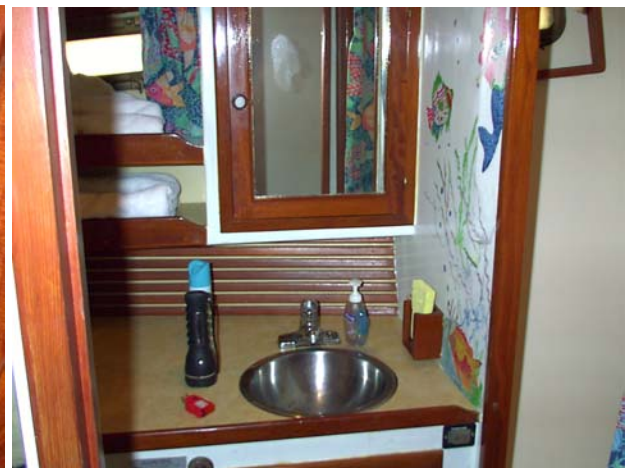
This vessel has the single head layout, which allows a queen-size bed to be located on the centerline of the stateroom and plenty of storage possibilities. I would think this would be the more popular option for a couple who wants to spend extended periods aboard, due to the increased closets and larger bed. Under the bed pedestal is where the 60 gallon waste holding tank is located, as well as the overboard discharge pump, Y valve and shower drain sump system are all located. When I lifted the mattress and removed the compartment covers, I immediately knew there was a problem due to the smell. At some point, the waste discharge pump has been operated without first opening the thru-hull seacock. This made the pump build up enough

pressure to force the hose free from the barbed fitting and empty some of the contents of the waste holding tank into this compartment. There is a bilge pump in this compartment also which operated when tested. The following photo shows the mess, which has been there long enough to accumulate some mold.

- 2) \*\*\* Adjust and/or repair propeller shaft stuffing box as required to stop the inflow of water into the bilge while underway.
- 3) \*\*\* Reconnect overboard discharge hose to waste pump and clean forward bilge area. Hose should be secured in a way to ensure it does not come loose again as it terminates below the vessel's waterline.

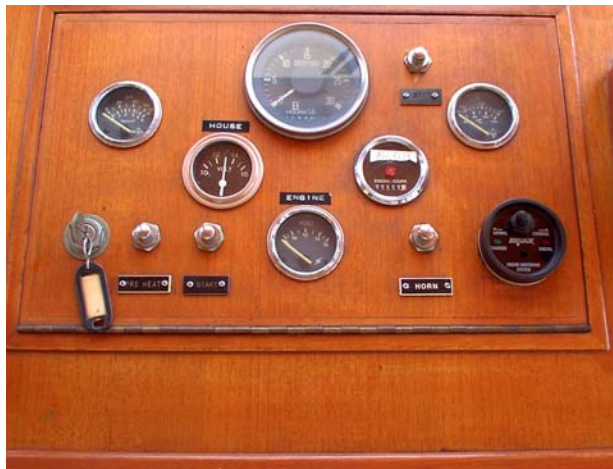
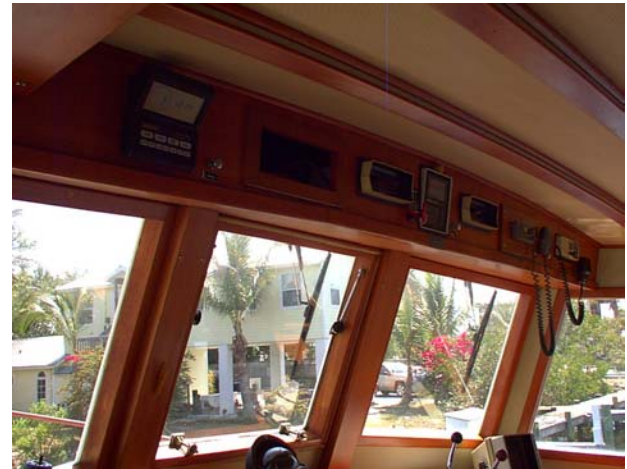
Moving upstairs to the pilothouse, one finds a very bright and airy space. The pilothouse is large and uncluttered. There is ample room on the settee for a few passengers to sit and watch the waterway go by on an inclimate day or for the captain to catch 40 winks while on an extended cruise. Visibility is very good from the pilothouse to all areas except the stern. The helm is well

laid out and very simple. Several electrical items were mounted over the windshield including the loran, the depth meter and the VHF radio. Of these three, only the VHF radio operated. There is also a non-working, older GPS on the helm. There is a 21-mile RADAR mounted to the starboard side of the helm station, which operated very well, and a SSB radio next to the settee, which powered up when tested. The windshield wipers, horn, spreader lights, strobe light, running and anchor lights all worked when tested. There are volt gauges to monitor the state of the charging systems for both the starting battery and the house batteries, while underway. There are also full size chart drawers to the port side of the helm and a keyboard drawer to starboard.

- 19) Suggest replacing outdated, inoperative electronics on helm (depth meter, LORAN, GPS).
- 20) Repair all low voltage lighting as needed (guest stateroom, aft salon, overhead engine room).

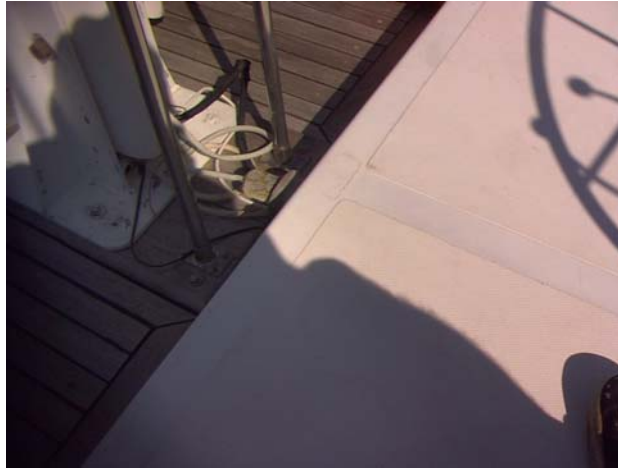
Finally, moving up the aft deck ladder to the boat deck, I again found the teak floor covering to be in rough shape. There is quite a bit of room on this deck for outside storage. The deck is surrounded by a stainless steel railing of proper height, to guard against falling overboard. There is an 800-pound capacity, electric crane attached to this deck which operated when tested. This crane can be used to launch the 8', Avon inflatable dinghy that is powered by a 9.9 horsepower, Yamaha 2 stroke outboard engine. This engine was not tested. The inflatable appeared in good condition. The controls for the crane are stored in the port side storage seat on the flybridge. There is a set of aluminum boarding stairs stored on the deck for use when the dock being used is lower than the main deck height of the vessel. The flybridge helm is simple and weathered. There is a stainless steel destroyer style wheel and Morse controls. There are remote controls and displays for the depth meter and LORAN but were non-functional. The autopilot was functional when tested on our sea trial. As stated earlier, this would be the favored location for operation of this vessel, weather permitting, due to its unobstructed 360° view. The bimini top was in fair condition, but the straps, which hold it in place, were all broken. There was also a bridge cover,

which was not in use. There are storage lockers to the port and starboard sides of the flybridge helm. Fuel for the dinghy and other miscellaneous items were located in these lockers as well as more wasps.

- 14) Replace torn screen and worn weatherstrips as needed on salon windows.
- 15) Develop a repair plan to restore the teak covered decks back to good condition.
