**DCH Marine, Inc.**  
**141 Paddington Rd.**  
**Venice, Fl. 34293**  
***Captain Don Hunter, MMS***  
**(941) 485-0999**  
U.S. Surveyors Association Member #40208H  
www.dchmarine.com

June 13, 2003

Our File # 03-113

Thank you for the assignment to document the above referenced claim for damage to the engine on Mr. vessel, allegedly from overheating caused by a restricted water inlet.

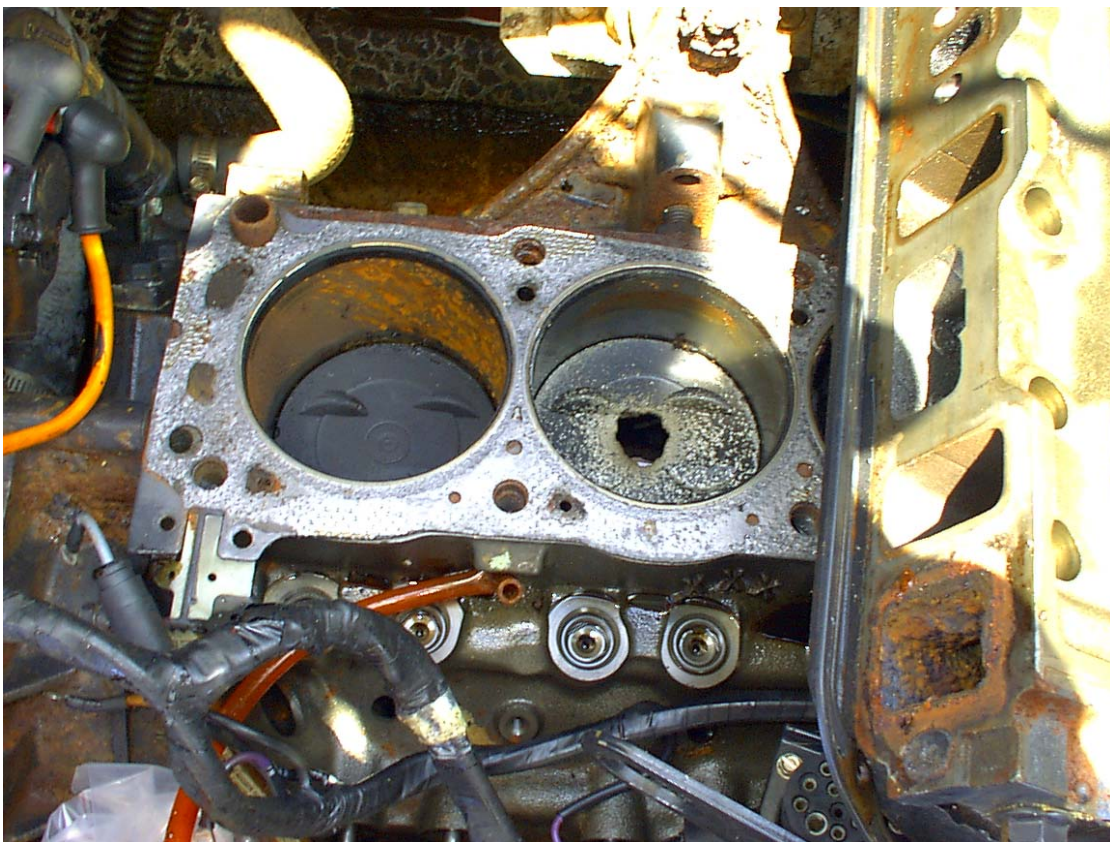
I started the inspection expecting to see an engine which had overheated to the point of blowing a head gasket or possibly cracking the cylinder head thus allowing water into the affected cylinder. That scenario sometimes causes a piston top to become very clean, almost looking brand new from the cold water being sprayed into a hot combustion chamber and loosening all the carbon which has built up over the years and expelling it out the exhaust. This engine was partially disassembled and I could find nothing visibly wrong with the head gasket on the right engine bank, no visible cracks in the cylinder head, no rust stains in the intake manifold for the affected cylinder, virtually no signs of water ingestion anywhere. The affected cylinder is the #2 cylinder, which is the second cylinder from the front of the engine on the right side, as viewed from the rear. The following photo shows the damage. In this photo, front is to the left.

As you can see there is a good size hole in the piston and the aluminum has gotten hot enough to spatter and stick to the rest of the piston and to the cylinder head. This usually does not happen from water getting in the cylinder. Engines usually do not get overheated enough to cause this

type of damage, they will usually seize up first from the oil being burned off of all the moving parts from the heat. By this point I had ruled out overheating as the cause of damage. I also examined the propeller and outdrive and noticed there was no “new” damage. There was a lot of old damage, but no recent evidence of grounding. See the following photos and notice the condition of the outdrive. The corrosion damage is fairly extensive.

Unfortunately, this looks like a case where an attempt to save money is going to end up costing quite a bit. Obviously, the insured has some amount of mechanical ability, how much is unknown. This problem was caused by a simple mistake of replacing two plug wires in improper positions. This led to one of the cylinders' ignition timing to be advanced so far, it detonated a hole in the piston. I asked the service manager at Marine if they would consider removing the engine, replacing the piston and performing a valve job to clean up the heads. This is the most cost-effective means of repair for this engine and it is very feasible because it was not overheated and there was no salt-water ingestion. There is also very little wear on the cylinder walls. The manager agreed it could be repaired this way but said there would be no warranty on the work. I don't think that is going to be a problem as there was no warranty on a vessel which is 7 years old and has 447 hours on the engine anyway, and this repair method will put the insured almost exactly back to pre-loss condition.

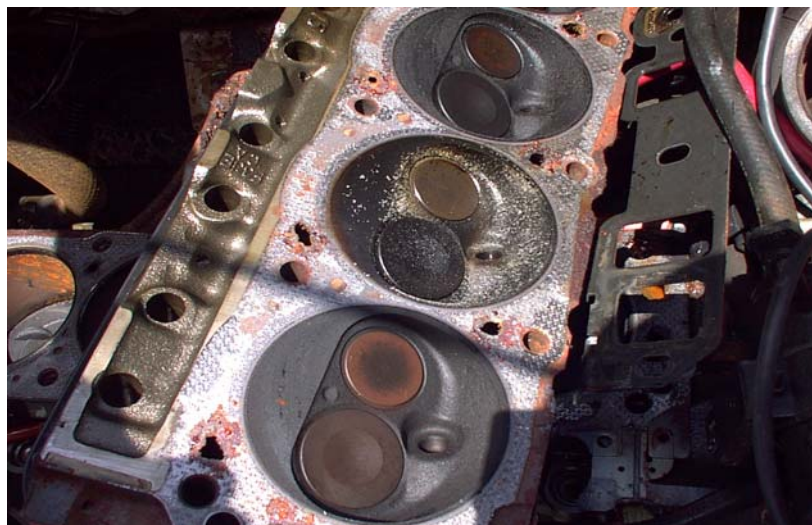
While examining the cylinder head I noticed the spattered aluminum had migrated past the intake valve upstream towards the intake manifold. This is unusual because usually the melted aluminum, which doesn't stick to other engine parts, usually exits the engine through the exhaust. I never seen the melted aluminum remain hot enough, through the pistons remaining 3 strokes, to get up past the intake valve in the head. There is some time during the running cycle when both valves are open. This period is known as “valve overlap” however, on a marinized engine, this time is greatly reduced in order to keep sea water from being pulled back into the cylinder during the overlap period. This fact made me look elsewhere for the cause of the melted aluminum up in the intake channel of the head. Notice in the following photo how there is still carbon on the head surface, a sure sign there was no water in there. The silver is all spattered aluminum, melted from piston.

OK, at this point we have an engine which did not overheat and there is a hole in one piston not caused by water intrusion. That only leaves severe detonation (pinging) as the cause but only on one cylinder. Usually detonation is caused by too low of an octane rating on the fuel used for the compression ratio of an engine or the ignition timing is too far advanced.

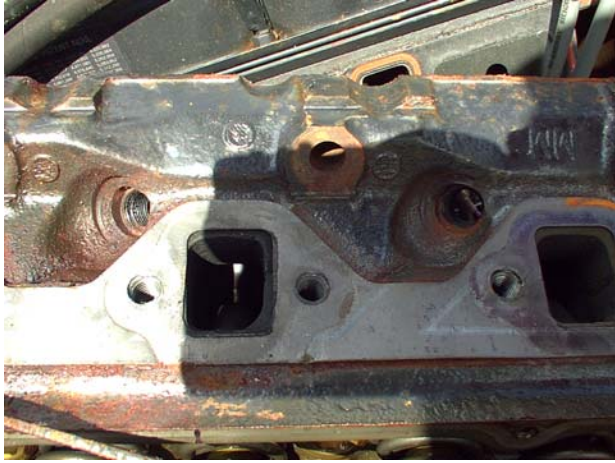
1

As I examined the exhaust ports on the right side cylinder head, I noticed the two center cylinders appeared to not have been firing correctly for some time based on the wet residue around the valve stems caused by unburned fuel being exhausted past them. The two outermost exhaust ports had dry residue, consistent with a properly (or at least more normally) burned fuel/air mixture. I tried to capture how different these ports look in the following four photos, but it doesn't photograph easily. Basically, this means the two center cylinders were not firing properly on the right bank of this engine prior to disassembly. The spark plugs had been discarded, so I was unable to view them. One of these malfunctioning cylinders was #2, the one with the hole in it, as you might expect. The other malfunctioning cylinder was the one next to it, #3. We'll number the photos below from left to right starting at the top. Photos numbered 2 and 3 best show the difference in the residue in the exhaust ports. Photo #5 shows the new riser reportedly installed by the insured.

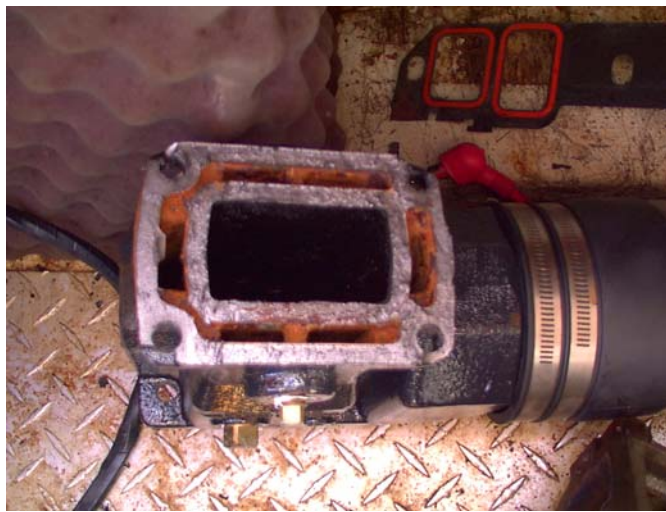
5

Continuing to work backwards in time from the time of damage, I noticed the insured had recently installed new exhaust manifolds and risers sometime prior to the loss. This in itself is a good thing, as these parts are one of the leading causes of premature marine engine failure. I didn't think these parts being installed had anything to do with the damaged piston. It was when I dug through the pile of removed parts from the disassembled that I realized what had happened to this engine. There were new plug wires in the pile. They looked as if they had been installed about the same time as the exhaust manifolds, which would make sense, as they have to be removed to take the manifolds off the engine. At this point I realized what caused the number 2 piston to detonate to the point of failure while the number 3 piston next to it wasn't burning all the fuel supplied to it. The person who installed the new plug wires mixed up the two cylinders. They put the wire intended for number 3 on the number 2 plug and vice-versa. It can happen very easily because of the extent that everything is disassembled to change the manifolds.

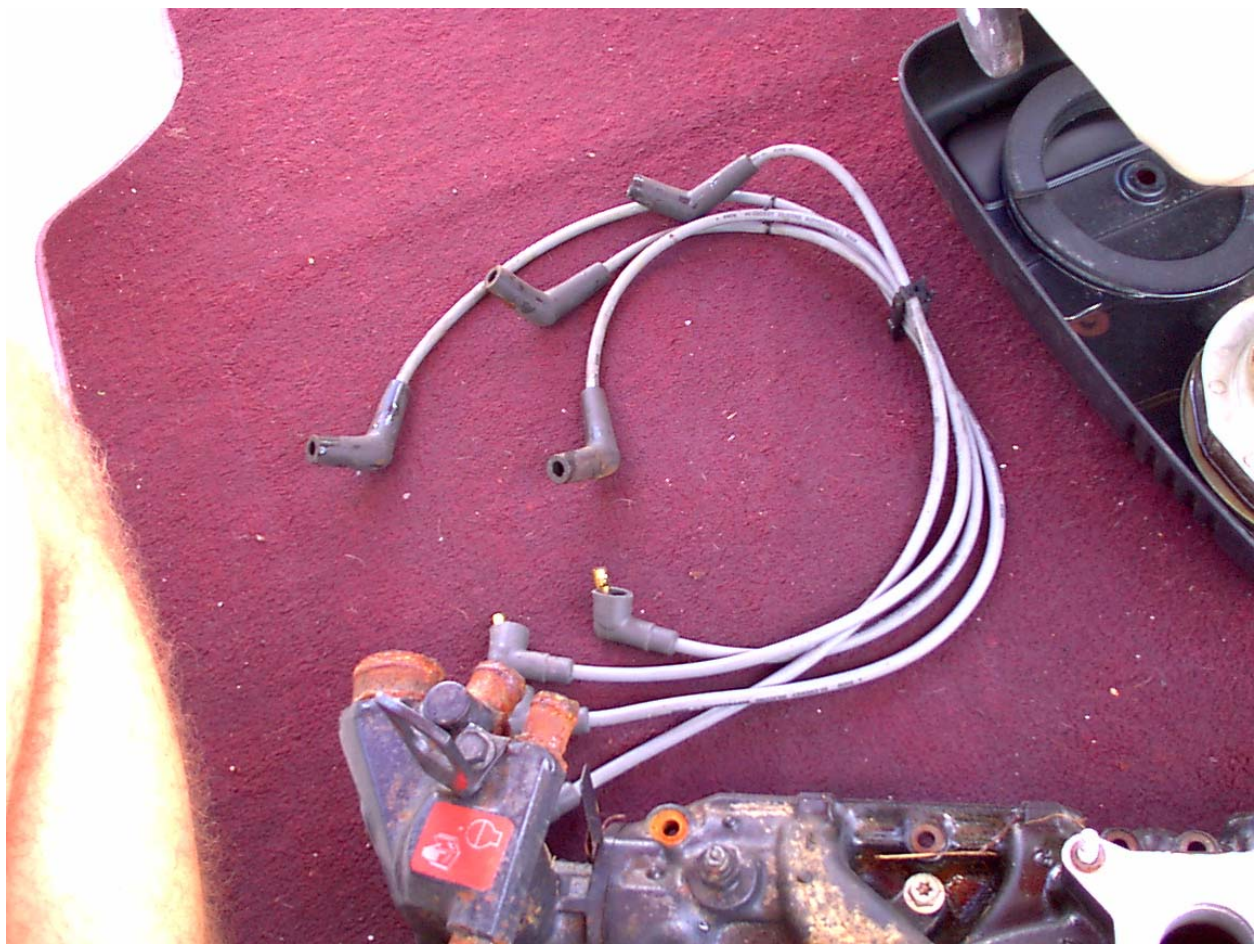
I asked the service manager, if he could put aside his liability concerns long enough to look up the cylinder firing order for this particular year and model engine. He did. Every engine has a specific order in which the cylinders fire in order to minimize vibration and reduce undue stress on the crankshaft. Now stay with me here! This particular engine fires in the following order: 1,3,7,2,6,5,4,8. Ford engines' cylinders are numbered 1,2,3,4 on the right bank and 5,6,7,8 on the left bank. This claim involves a hole in the #2 cylinder and the unburned fuel residue in the cylinder next to it, #3. Let's say you swap these two plug wires, what would happen? According

to the firing order #2 would fire in place of #3, a full 2 positions early. How early is that? Well, there are 360° in a full crankshaft revolution. This is an 8 cylinder engine, so  $8 \div 360^\circ = 45^\circ$ . That means there is a piston firing at every 45° of crankshaft rotation. Now take one cylinder and move it up two places in the firing order. That cylinder is now firing approximately 90° before top dead center, and that's at idle!! That means it could be as much as 130° before TDC at 3000 rpm!! The engine would still run because the other cylinders would carry the load, but when the #2 cylinder fires, the tendency would be for the crankshaft force to be slowed at that point. This would cause really poor performance and severe detonation on one cylinder. As RPM increases, the problem gets worse. This explains how the melted aluminum got up inside the intake valve port. At some point, the RPM actuated advance is enough to cause the burned fuel to be forced back up the intake port because the intake valve is still open to allow the fuel to get into the cylinder! Now, the #3 cylinder has the #2 wire on it, so in this scenario, that cylinder is firing about 90° after it should. This condition is not as dramatic as the other cylinder, but it does cause the fuel/air mixture in the cylinder to be expelled through the exhaust before it is fully burned, so this cylinder is not putting out its full potential and it is leaving a wet residue in the exhaust port. How long does it take to do all this damage? Well the insured stated it is about a 45-minute trip to get to where the engine trouble started. This was mostly at low speed. The engine hatch is somewhat soundproofed, so he may not have heard 1 cylinder pinging. About the only sign he would have had would have been poor performance and higher than normal operating temperature, both of which he mentioned in his statement. He said the boat acted like it was overheating, but the gauge only read a little over normal, certainly consistent with the scenario set forth above. So, round trip, 90 minutes with one cylinder running at an average timing advance of 90°, that's long enough to melt a piston for sure.
