**DCH Marine, Inc.**  
**141 Paddington Rd.**  
**Venice, Fl. 34293**  
***Captain Don Hunter, MMS***  
**(941) 485-0999**  
U.S. Surveyors Association Member #40208H  
www.dchmarine.com

March 21, 2004

***Our File #*** 04-102

The subject vessel is a 1984 Kadey-Krogen 42' trawler. The vessel bears hull identification number XXXXXXXXXX and Florida state registration # FL XXXX XX. This vessel is named "XXXXXX". It is powered by a single Ford/Lehman six cylinder, naturally aspirated, 120 horsepower, diesel engine. There is also an 8kw generator located in the engine room.

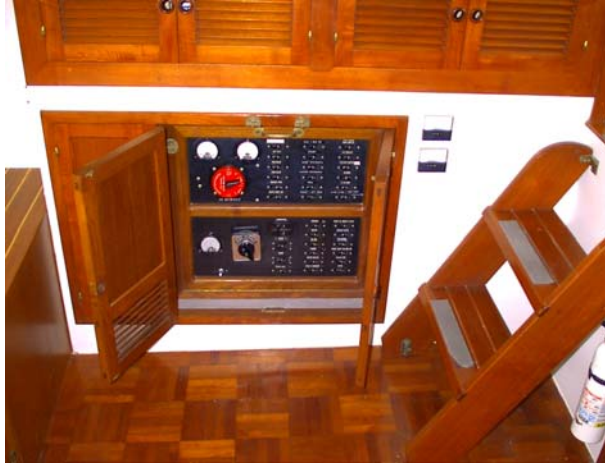
Across from the galley on the port side is where one finds a set of upper and lower cabinets at the stairs, which lead to the pilothouse. The bottom cabinet houses the A/C and D/C circuit breaker panels. The upper cabinet houses a liquor cabinet and more storage area. On the aft facing side of this cabinetry is where the control panel is located for the Heart Interface system. Also located in the lower panel are the controls for the generator and shore power-to-generator switches. The following picture shows the electrical control panel.

- 6) \*\*\* Repair/replace ground fault outlets in salon at the starboard salon-to-galley transition and the salon port side aft.
- 7) \*\*\* D/C voltmeters inoperative at main circuit breaker panel in salon. These should be repaired so one can see excessive drops in voltage while operating circuit breakers.

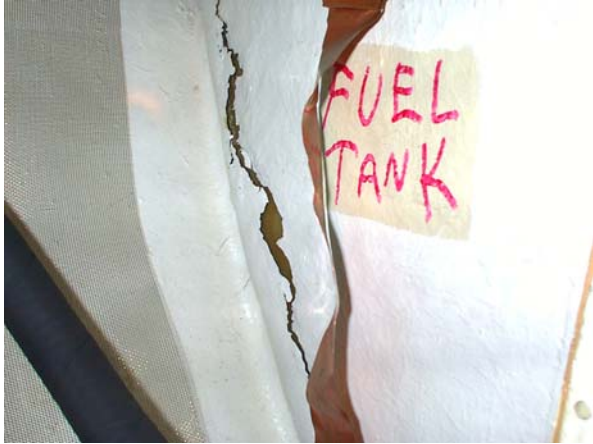
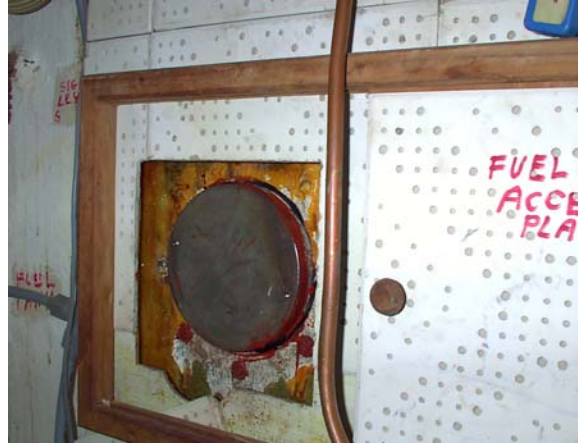
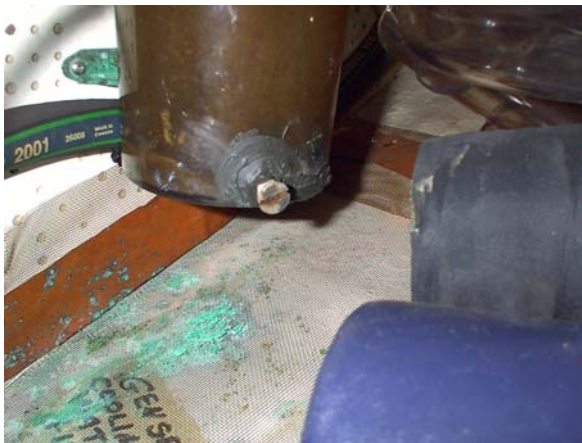
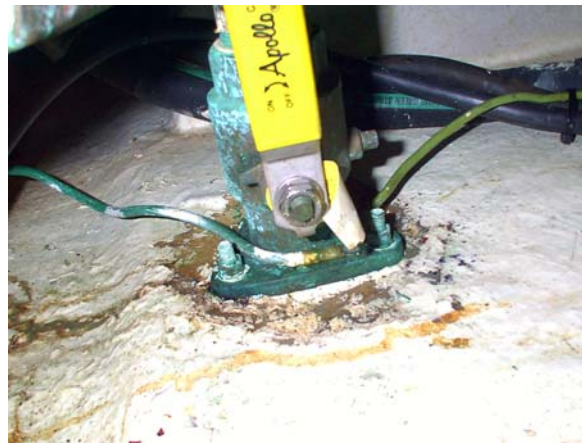
The fuel tanks on this vessel are very large and located to the port and starboard sides of the engine room. The builder reported these tanks are made of steel, coated in epoxy and hold 350 gallons of fuel each. I noted the tank on the port side had some fiberglass taping coming loose where it is attached to the hull. The starboard side has had the screw in inspection port sealed from the outside with a RTV type sealer. The following two pictures show these two items. Some other items of interest in the engine room follow. The seawater strainer bowl for the genset has been broken and repaired, the thru-hull seacock for the genset is leaking seawater at the hull. This leak is where the seacock passes through the cored hull. I also noted a large amount of barnacles growing inside the sea strainer for the air conditioner seawater pump.

- 16) Repair fiberglass taping on aft edge of port side fuel tank-to- hull joint.
- 17) Repair stress crack in port side hull bottom and keel seam aft in conjunction with a bottom job to ensure no seawater is allowed to enter into the coring material.

- 24) Suggest carrying spare O-rings of the proper size for the inspection ports on the fuel tanks, none were found on board and some dry rot was noted on the port side.

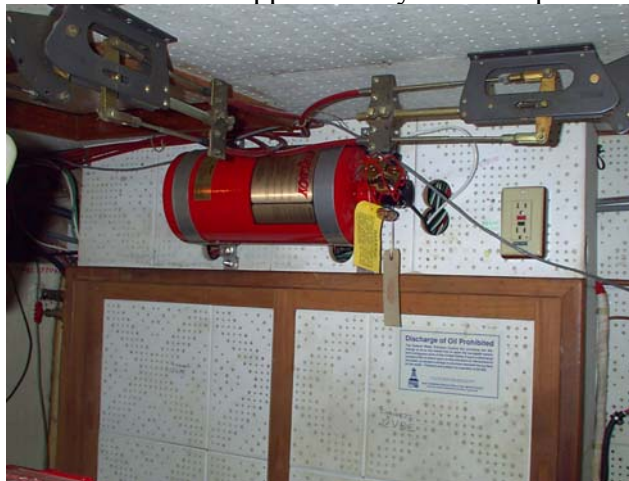
Overhead in the engine room there is a 32 pound Halon fire suppression system which can be discharged manually as well as automatically. It was installed in 2002 and has not been serviced since. The gauge reads full. Also located in the engine room is the water heater, accumulator tank, filter and pressure water pump. This water heater is the 4th one installed in this vessel, according to the log. Judging by the amount of time all the previous water heaters lasted in this vessel, I would tend to think this one is within a year or so of needing replacement however, it was working well when tested and shows no signs of leakage. The pressure water pump is rated at 4 gallons per minute and worked well. The cartridge type water filter is located under the galley. Age of the current cartridge is unknown.

The house battery bank was inspected and service dates of the batteries were logged in the data section of this report. All cells were full when inspected. All the cables and wiring for this system appeared in order and in excellent condition. The charging system for the house batteries while under way is provided by a high amperage output alternator, located on the port side of the engine. This alternator, brackets and drive belt all appeared new. Output was good when tested. There is a main fusible link for this system, located on the port side stringer near the back of the engine. There were spare fusible links of various amperages noted under the pilothouse helm station. The following pic shows the fire suppression system and power distribution cabinet.

- 21) Suggest having life raft serviced and updated as needed.
- 22) Suggest having all fire extinguishing systems serviced by qualified personnel.
- 23) Suggest formulating a repair plan for future repairs to port side stringer at forward engine room bulkhead.

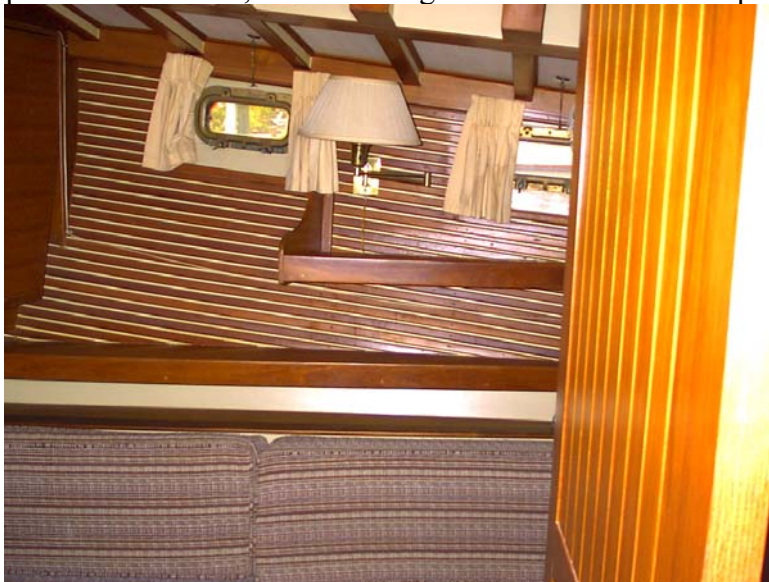
The guest stateroom was next. This vessel has been built with the “den style” guest stateroom. It has a desk against the forward bulkhead and a settee against the outside hull wall which, converts into a double berth. There is also, what I would call, a Murphy bed affixed to the forward bulkhead over the desk which can be lowered to provide another single bed. The walls and floor are all covered in teak and there are 2 portholes to allow some light and air into this space. There were 4 lamps located in this room but I could only get 2 of them to operate. All the electrical outlets tested OK in this room. There is also a hanging closet aft and a set of built in drawers. In the closet is where all the attachments were stored for the central vacuum system. Please forgive the photo of this room, it is not that good due to the limited space.

- 19) Suggest replacing outdated, inoperative electronics on helm (depth meter, LORAN, GPS).
- 20) Repair all low voltage lighting as needed (guest stateroom, aft salon, overhead engine room).
