**DCH Marine, Inc.**  
**141 Paddington Rd.**  
**Venice, Fl. 34293**  
***Captain Don Hunter, MMS***  
**(941) 485-0999**  
U.S. Surveyors Association Member #40208H  
www.dchmarine.com

June 13, 2003

Our File # 03-113

Thank you for the assignment to document the above referenced claim for damage to the engine on Mr. vessel, allegedly from overheating caused by a restricted water inlet.

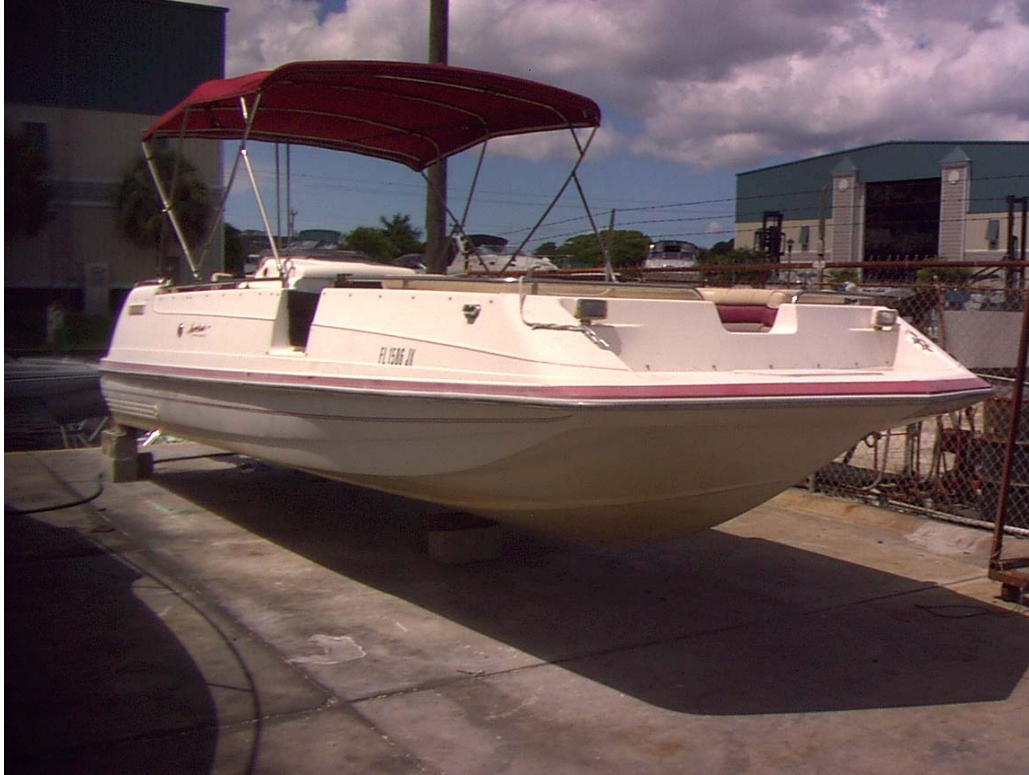
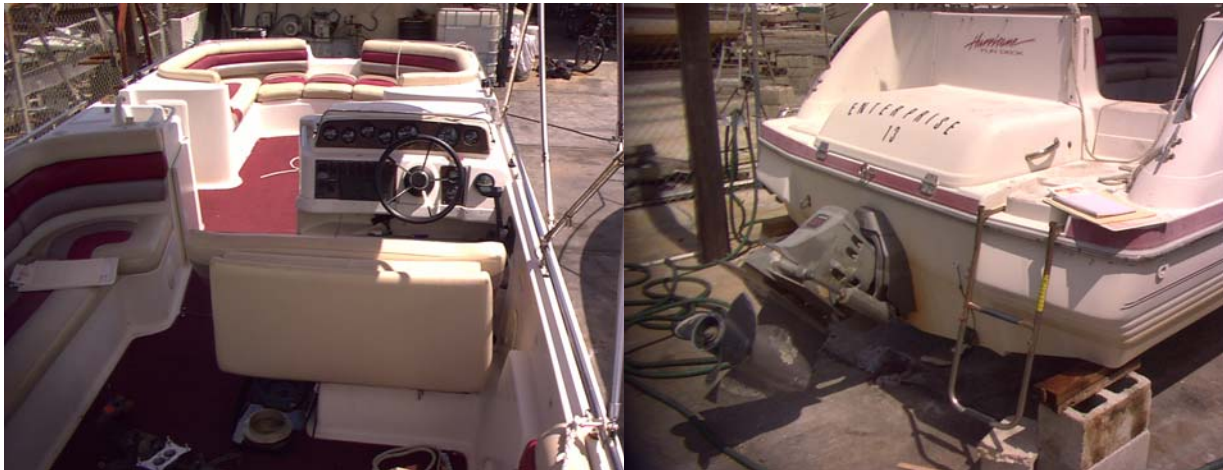
The vessel is powered by a single stern drive or inboard/outboard unit manufactured by Volvo-Penta Marine Group. The base engine is a Ford, 302 cubic inch, 5 liter, automotive engine which has been converted for marine use by Volvo-Penta Marine. The engine hour meter currently reads 447.0 running hours. The outdrive unit is manufactured by Volvo-Penta directly. It is a model # SX-C1 and bears serial number 4112017665. It has a 1.65:1 gear ratio. The engine is mounted in the vessel in the standard layout fashion, that being located all the way at the stern and it is covered by a sound deadening, lift-up type engine hatch. The engine is raw water cooled, meaning the engine uses water from the body of water in which it is operated in, for cooling purposes. The insured has owned the vessel since new and it was purchased at the facility, which is currently doing the repairs. The insured performs most of his own maintenance, according to the repair facility manager. The insured does not have a trailer for the vessel so the repair facility hauled and blocked the vessel in their repair yard when Sea Tow brought it in. The following photos show the cosmetic condition and layout of the vessel. The hull is badly weathered and chalked and the cushions are sun rotted. The insured stated he has ordered new interior cushions. The engine has recently had the spark plug wires changed and the exhaust manifolds and risers replaced. All of this work was performed by the insured.
